US Army Corps  
of Engineers  
Construction Engineering  
Research Laboratory

TECHNICAL REPORT P-85/13  
June 1985

# Design Criteria Upgrade for U.S. Army Type II Air Traffic Control Towers

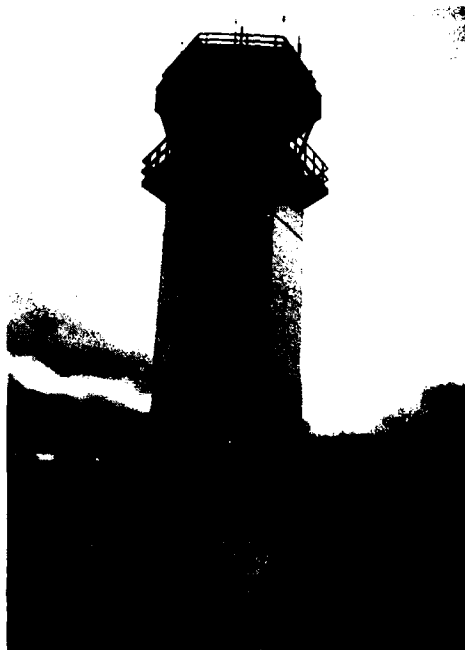
**Figure 1.** Type II ATCT exterior view (runway side).

The Type II ATCT at Fort Huachuca, AZ (Figures 1 through 7) was examined and problem areas were recorded based on observations and discussions with ATCA and tower personnel. Problem areas in other Type II ATCT installations were also compiled. Construction documents for towers at Fort Huachuca, Fort Wainwright, and other Type II ATCT installations were examined, and problem areas identified. Areas for which design and construction upgrades would be appropriate were then determined and upgrade tasks defined. Finally, design and construction criteria were developed that addressed the identified problem areas and provided guidance for avoiding them in future Type II installations.

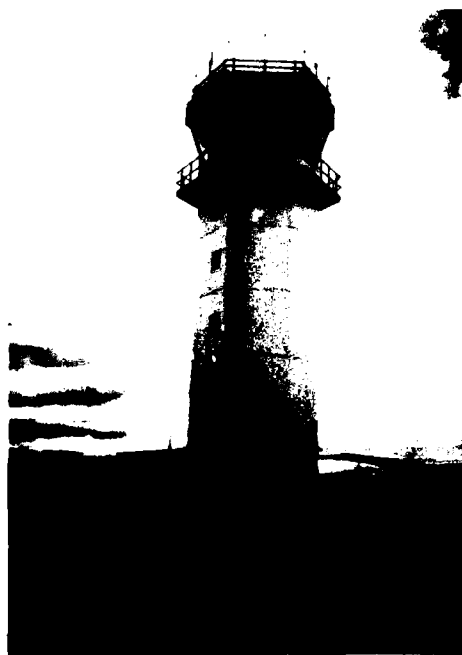
**Figure 2.** Type II ATCT exterior view (back side).
